**To:** All X-1R distributors

**Subject:** The Role of Blow-by in the formation of sludge

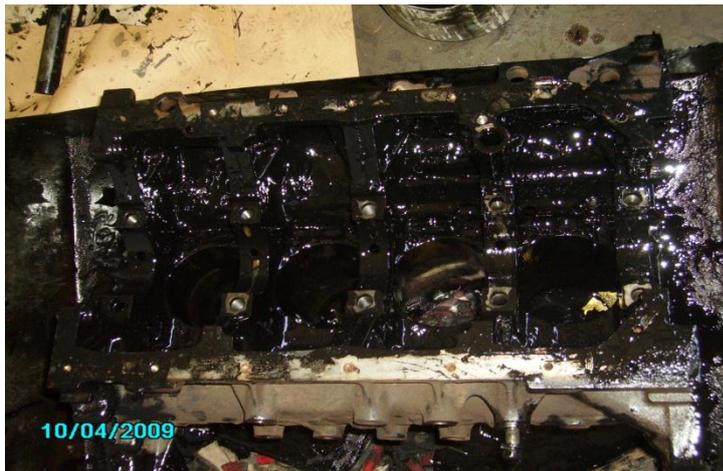
*“ Yesterday we were called to check on an engine which had been taken apart for over-hauling and which the mechanic was reporting unusual sludge deposits.*

*The vehicle had been overhauled after 100,000 Km’s and after a further 15,000 Km’s it had lost compression. This led them to take the engine apart and they found large quantities of sludge. The oil which has been used all along in this vehicle has been DS40, which is what the mechanic uses in all it’s commercial vehicles. They were using this before being introduced to X-1R and have continued to use the same.*

Picture above of sludge deposit from Distributor

***"blow-by" gases (air, exhaust gases and partially oxidized fuel) to get past the rings and to contaminate the oil. This oil contamination leads to the formation of massive amounts of sludge such as is seen in the pictures.***

***It seems to me that the problem resulted from a failure of the rings to properly seat following the overhaul. This led to loss of compression and a massive increase in blow-by, which in turn caused the sludge."***
