Land Rover Discovery Sport 2.0d Se 7-seater

Inspector: Loh Wei Chen

Date of Inspection: 29th April 2024

Inspection Checklist

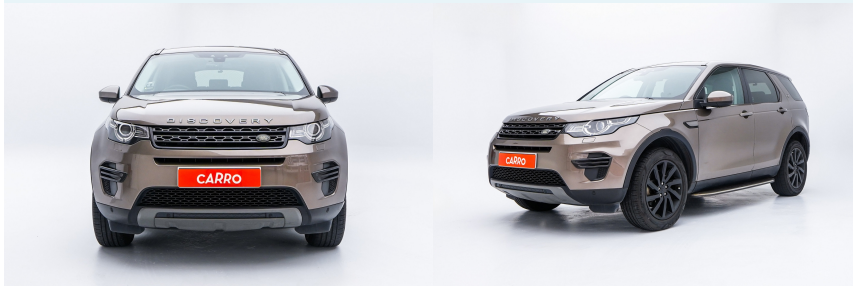
Exterior Images

Items	Status	Comments		Status	Comments
Door Seals (All Doors)	✓		Door Handles	✓	
Front Bumper	✓	Scratches	Front Fender (Left)	✓	
Front Doors (Right)	!	Scratches	Front Door Panel (Right)	!	scratches

Front Doors (Left)	 	Dented	Front Door Panel (Left)	 	dented
Front Bonnet, Support and Insulator	 	Scratches	Front Fender (Right)	 	
Rear Bonnet	 		Rear Fender / Quarterpanel (Right)	 	
Rear Fender / Quarterpanel (Left)	 	discoloration	Rear Bumper	 	Scratches
Rear Doors (Right)	 	Scratches	Rear Door Panel (Right)	 	scratches
Rear Doors (Left)	 	Scratches	Rear Door Panel (Left)	 	scratches
Side Skirt (Left)	 		Side Skirt (Right)	 	
Body Panel Inspection	 		Grille Inspection	 	paint peel out
Sunroof / Moonroof	N/A		Convertible Top	N/A	
Front Bonnet Release	 		Front Windscreen	 	
Rear Windscreen	 		Front Window (Left)	 	
Front Window (Right)	 		Rear Window (Right)	 	
Rear Window (Left)	 		Rear Quarter Window (Left)	 	
Rear Quarter Window (Right)	 		Rear Window Wiper Switch	 	
Windscreen Wipers Switch	 		Wiper Blades Front & Rear	 	
Power Window Controls	 		Left Side Mirror	 	
Right Side Mirror	 	scratches	Outside Rear View Mirrors
